ARLINGTON PUBLIC SCHOOLS

***Arlington School Committee
Standing Subcommittee: Facilities
Tuesday, February 25, 2025
5:00 PM***

Ottoson SOI planning – next steps

Ottoson Middle School: Property Overview

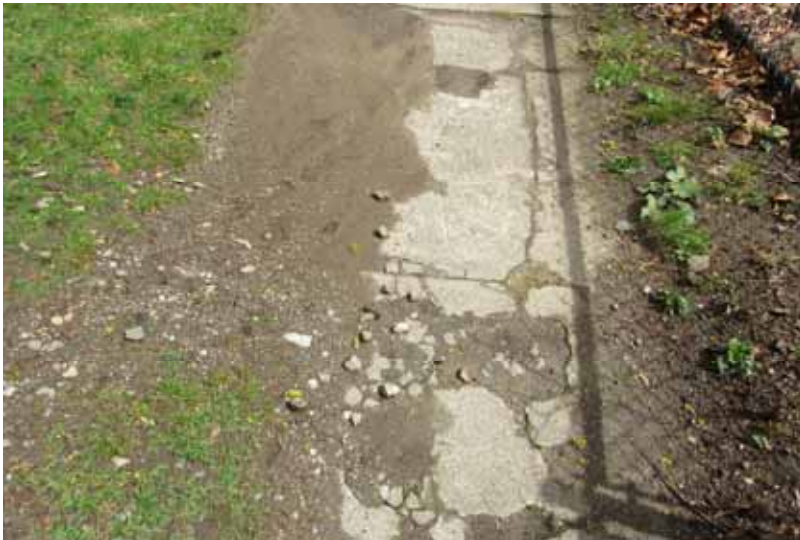
View of concrete deterioration within walkway
as seen towards southeast corner of building

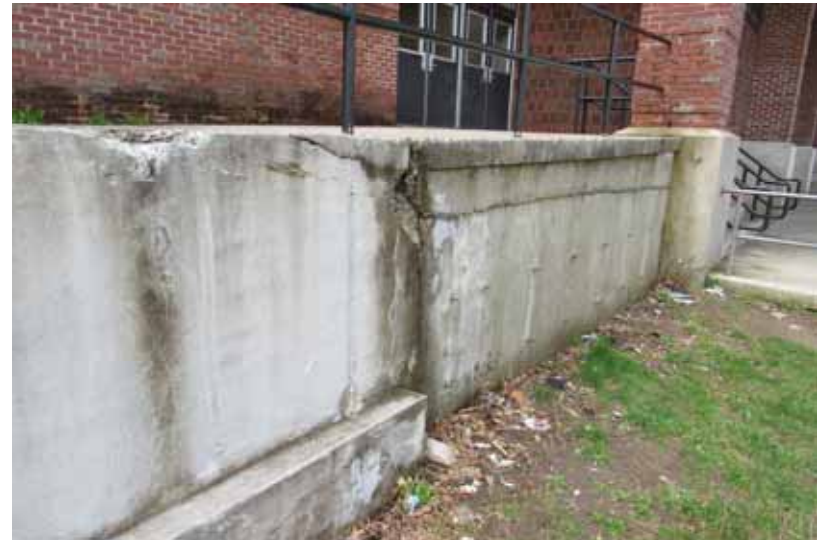
View of cast-in-place concrete retaining wall present towards
northeast corner of building – note concrete spalls/deterioration

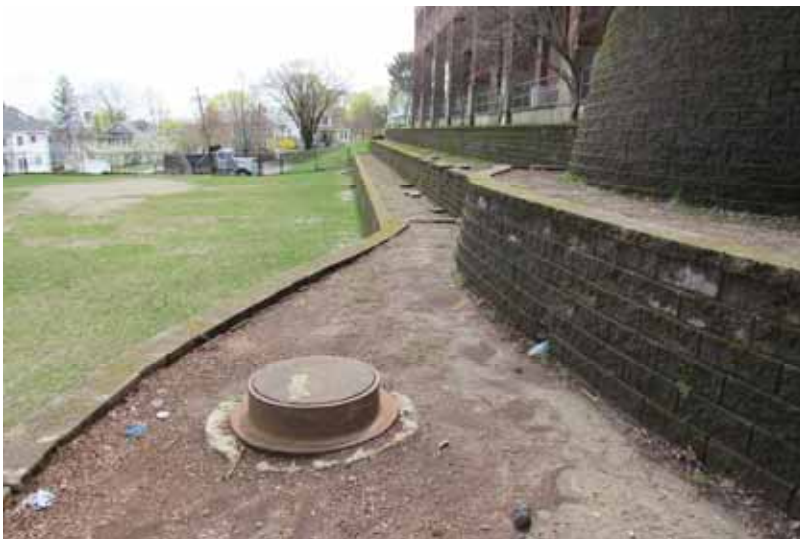
4. Several displaced concrete block masonry units were observed within the front elevation retaining walls. Furthermore, localized mortar loss/deterioration was noted within the development's perimeter stone retaining walls. Periodic costs to carry out as-needed retaining wall repairs/replacement are shown every five years starting in Year 1. These costs also include pressure washing of the segmental block retaining walls present at the front of the development.

View of concrete segmental block masonry
retaining walls as seen at north end of building –
several displaced masonry units noted

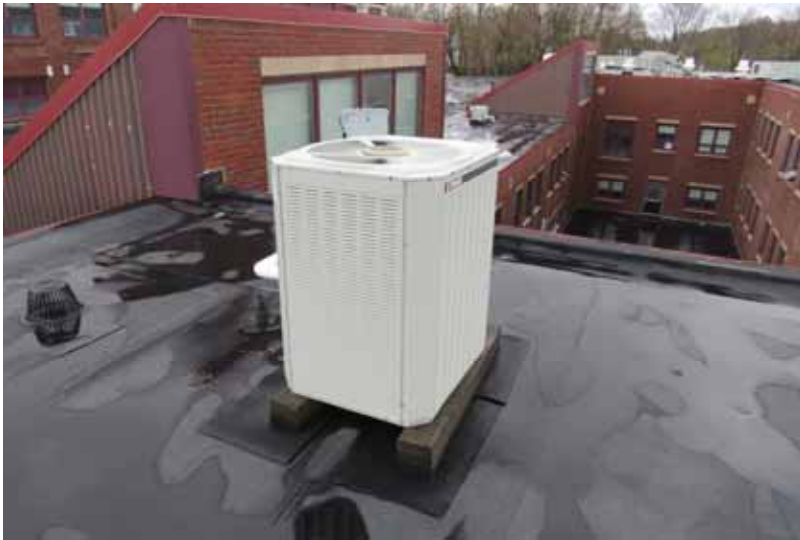
21. Three split-system air conditioners facilitate space cooling for the computer rooms. The air conditioners are operating beyond the end of their normal expected useful service lives, and replacement costs are shown in Years 1 and 16.

View of sample of split-system air conditioner (one of several) – unit in photograph serves computer room

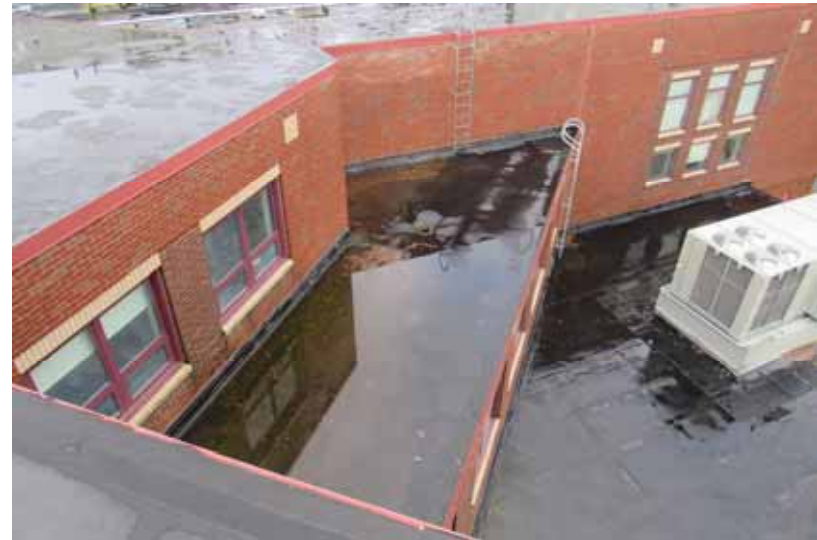
Additional view of water ponding on roof surfaces as seen at lower roof area
